# HIGHLAND CLACHAN

by  
Margaret Stewart

## THE CLACHAN

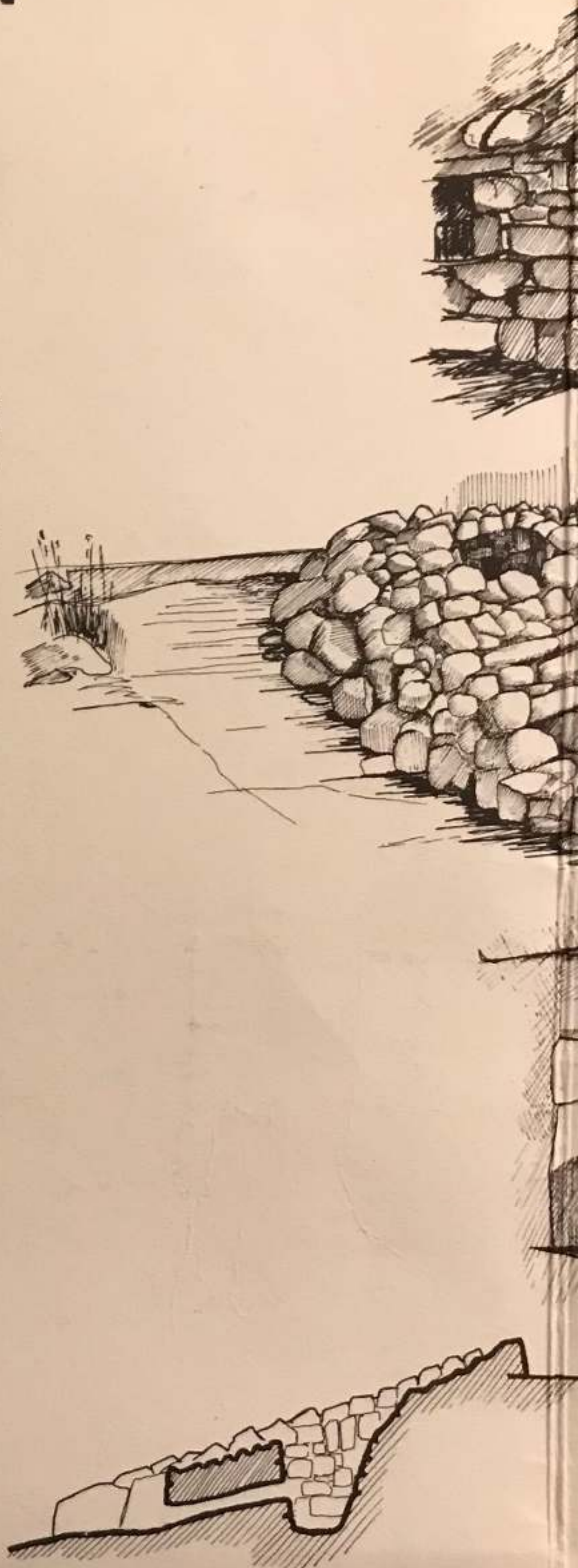
Section through corn drying kiln.

The corn drying kiln has been built into a natural slope in the northeastern part of the clachan. The chamber has been in part cut out of the living rock, with a thick collar of dry stone building at ground level.

The original lintelled flue is short and narrow but it has been lengthened at a later period by two wings built forward at either side. When used for corn drying the corn in the sheaf would be laid on a grid supported by a scarcement built halfway up the inverted cone of the chamber. A fire was then lit at the outer end of the flue and the heat, inducted inwards, dried the cereal without any risk of fire. Most deserted rural settlements in Perthshire have a corn drying kiln an essential adjunct when barley was sown as late as June and often not harvested until November. But with the agricultural improvements brought in at the end of the 18thC; with better seed, earlier sowing and summer harvesting the corn drying kiln became obsolete. Several examples in Central Perthshire like this one at the clachan were converted to burning limestone. Increasing the draught by lengthening and narrowing the flue was the usual method of conversion. At the clachan partly burnt limestone was found at the bottom of the chamber but the amount which could have been burnt at one time must have been minimal. However the small area of ground cultivated combined with the probable rate of distribution of approximately 2oz to the square yard must have reconciled the inhabitants to the inconvenience of production.
