Headquarters Machinery Development Committee

Report No. 28 on

The Use of a Grubber Blade for the  
Clearance of Derelict Woodland

R. G. SHAW

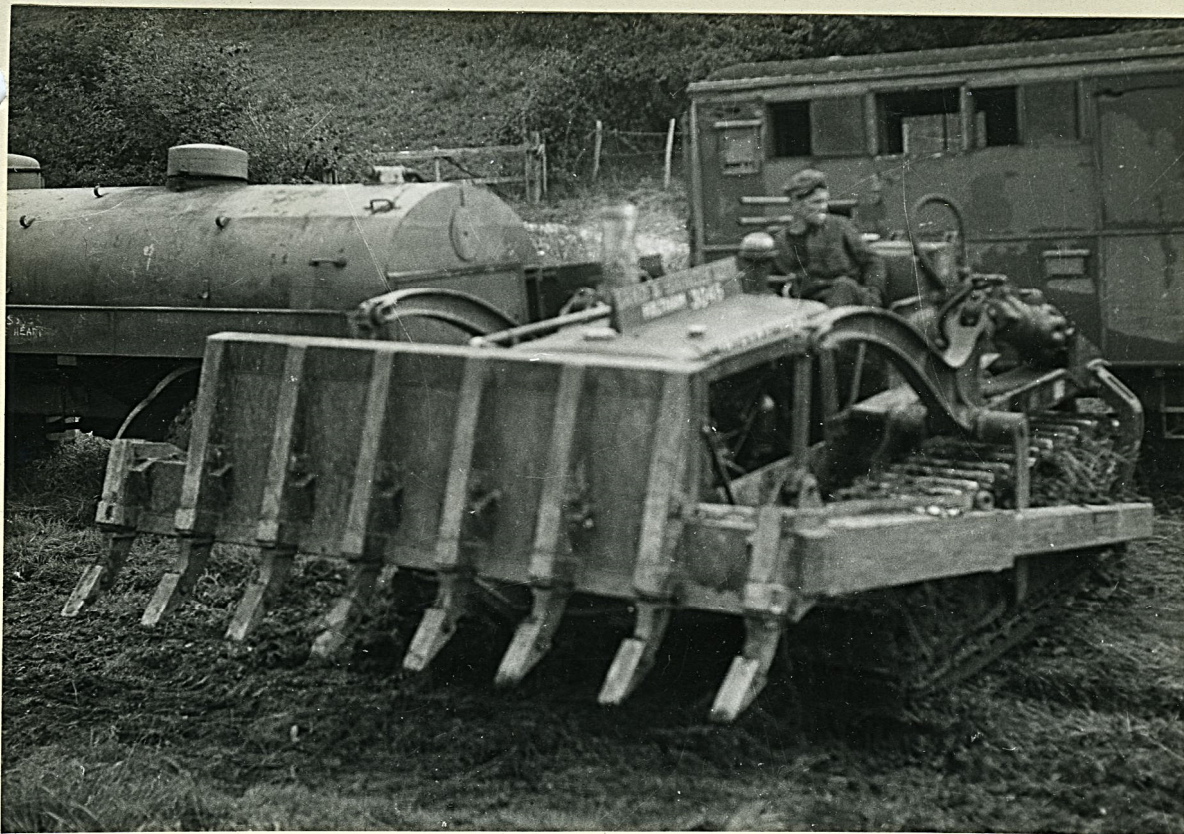
PHOTOGRAPH 1. The grubber blade mounted on a tracked tractor T.D. 14.

Two sizes of the Grubber Blade have been used, one to fit an International T.D.14 and another to fit an International T.D.18. Both were equally successful

For T.D.14 - £232 - 10 - 0 + £24 - 1 - 1 for fitting

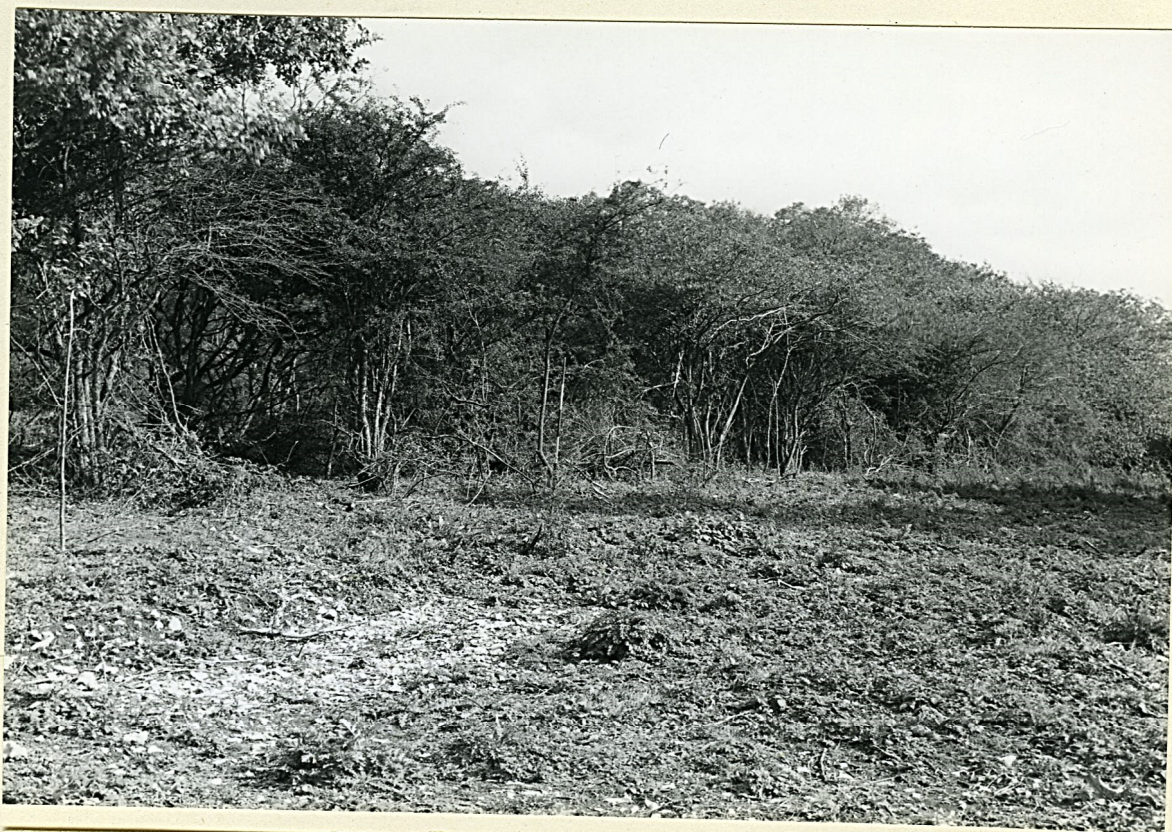
PHOTOGRAPH 2. A typical view of the ground at Charlton before clearing.

Burning of the windrows is necessary because they absorb a large proportion of the cleared area and also form an ideal retreat for rabbits. This burning operation requires much time and trouble. A typical example of clearing was provided on 42 acres at Charlton, Sussex where the standing crop was practically solid blackthorn interspersed with scattered oak, ash, whitebeam, yew and holly. The thorn ranged from 10 feet to 15 feet in height. The attached photographs show the density of the growth that was tackled and the state of the ground after the clearing operation. Most of the roots are removed by the tines but large hardwood stumps are left as they are expensive to grub out and their removal is not necessary for reafforestation.

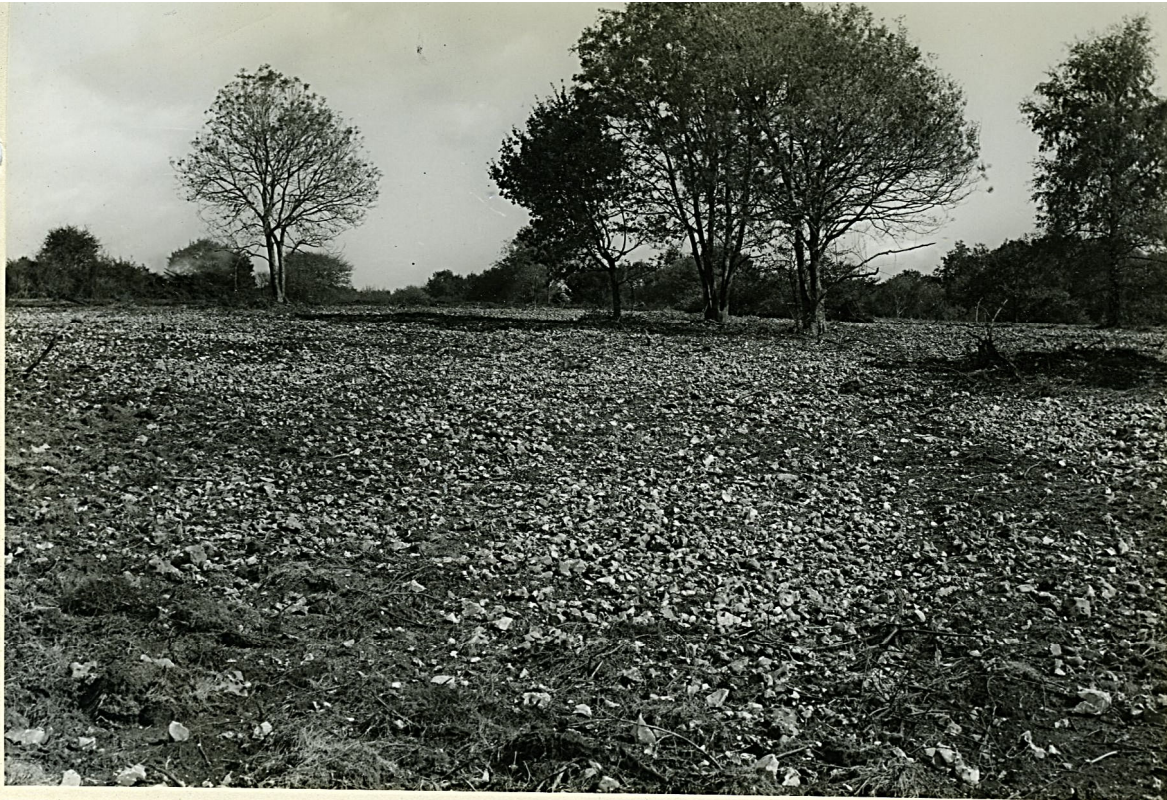
PHOTOGRAPH 3.

A section of the ground at Charlton after clearing. Note that certain selected trees have been left standing. The actual number of trees left standing depends upon local conditions.

The technique employed is to gradually cut into the standing timber and work it into windrows but leaving selected trees which could grow on to maturity and at the same time give protection to the newly planted trees.

The ground was left in a condition suitable for planting without further cultivation.

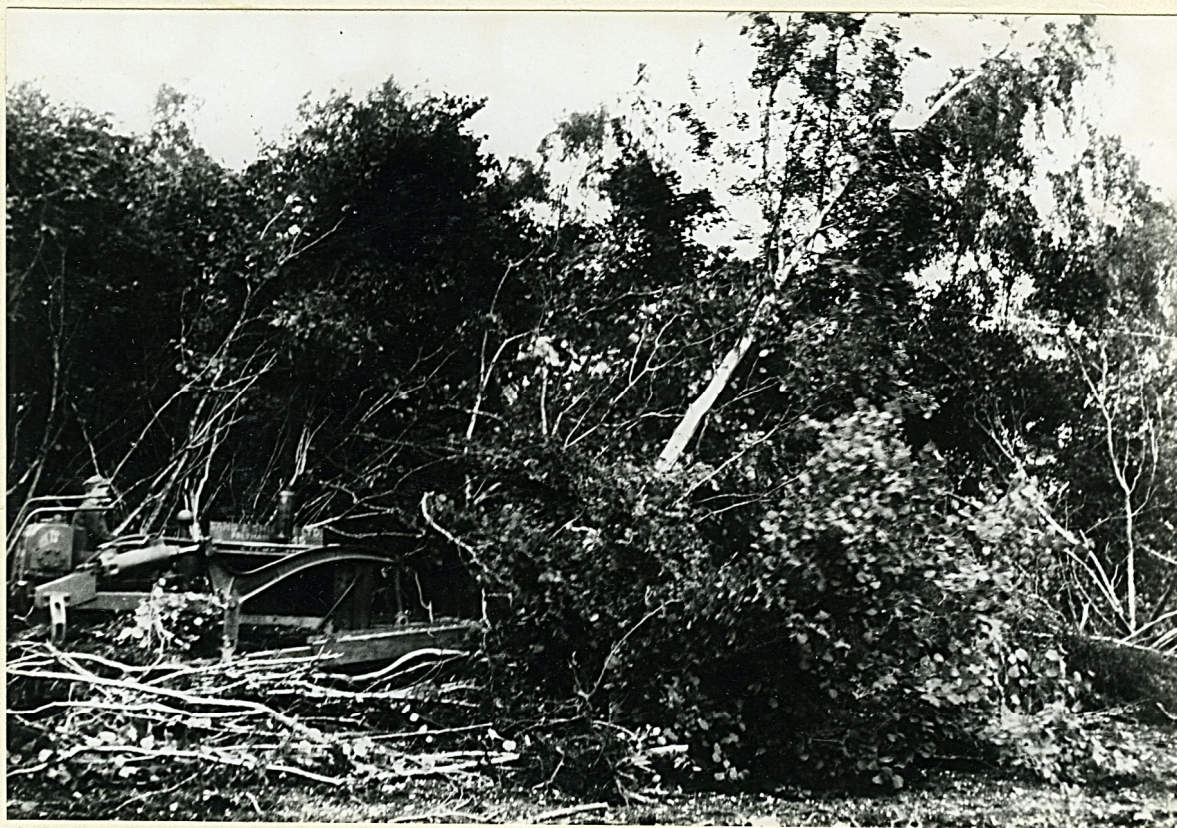
PHOTOGRAPH 4.

The T.D. 14. and grubber blade in action. This photograph was not taken at Charlton but near Blandford Dorset during an earlier clearing operation.
